National Energy
Board

Pipeline Incident Report

**Natural Gas Pipeline Rupture near
Fort St. John, British Columbia**

15 May 2002

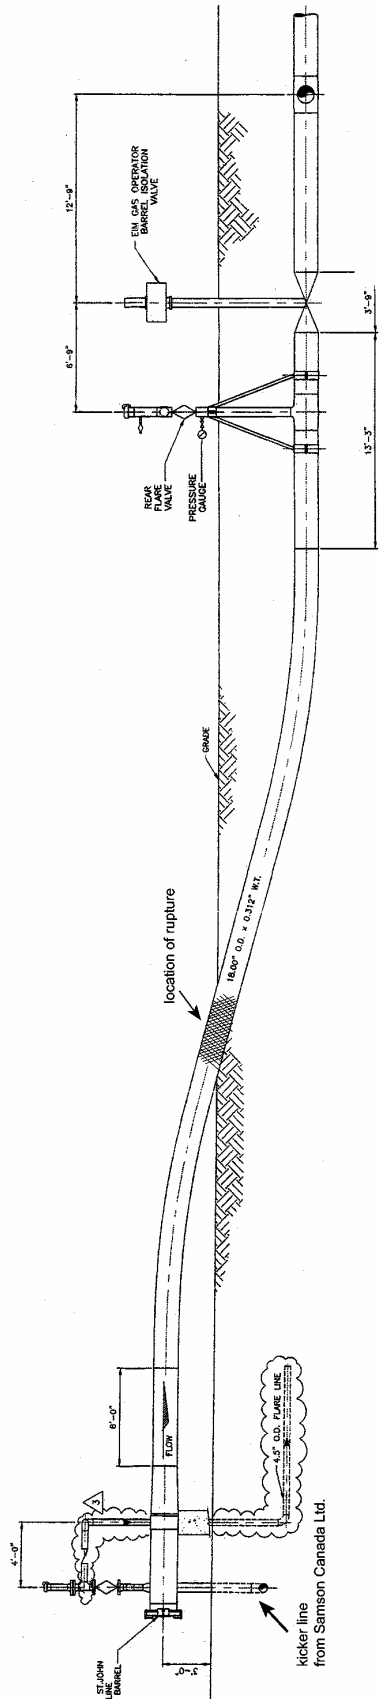
Figure A2: Schematic of Sending Barrel

Visual examination of the ruptured pipe revealed that the rupture initiated at a large lamination² in the pipe that was created during the original plate manufacturing process. It is well known that wet hydrogen sulphide inside the pipe dissociates to form iron sulphide and then releases atomic hydrogen. Over time, atomic hydrogen diffused

into the steel and accumulated as elemental hydrogen at the lamination in the centerline of the pipe wall. At the rupture origin, the accumulated gases had formed a large hydrogen blister³ bulging inward from the lamination and separating the inner ply from the opposing layer of material. Yielding of the inner layer of steel occurred, resulting in a permanent bulge and significant residual stresses associated with the bulge. Sulphide stress corrosion cracking (SSCC) was found on the inner ply of the steel that penetrated to the inside surface of the outer ply of steel. Shallow SSCC was also found on the inside surface of the outer ply of steel. The SSCC occurred in and around the bend zone, due to continuing hydrogen sulphide dissociation and the high residual stresses associated with the bulge.

As a result of substantial SSCC, the interior surface of the lamination, at the blister, was eventually opened up allowing a through wall path for gas and liquids to the remaining outer wall. It is assumed that at the time of the rupture the pressure inside the blister matched the internal pressure in the sending barrel. With the inner ply of the blister not providing support for pressure containment, the rupture occurred when the applied stress intensity at the outer ply crack tips exceeded critical levels. Calculation of the failure pressure, utilizing fracture mechanics models and using measured pre-existing defect sizes, indicates that the failure pressure would have been about 1000 psi. This level of stress is 30 per cent above that generated by the reported line pressure of 743 psi.

Since the fracture mechanics analysis indicates that the pressure required for the rupture of the pipe exceeded the reported line pressure, an additional event or stressor would have been required to cause the rupture. This would most likely have come from the suspected hydrate plug being dislodged and creating a pressure wave within the pipeline. There was no evidence within the ruptured pipeline remains that would prove the presence of a hydrate plug. However, the pressure differential reported by the operator prior to the pipeline rupture can only be explained by a plug between the rear flare line gauge and the barrel door gauge. The operator's actions of attempting to purge and depressurize the

barrel would have been enough to cause the hydrate plug to dislodge. When the blockage became dislodged, a "hammer" effect, sufficient to initiate fracture in the steel, was generated.

As a temporary repair, the barrel, S-bend, and isolation valve were removed and an end cap installed in order to return the 18-inch Fort St. John pipeline to service. Westcoast returned the pipeline to service on 18-May 2002.
